Protecting the Unique Ecosystem from Contaminated Storm Runoff at Mammoth Cave, KY

Ashley West¹, Carlton Cobb¹, Brandon Cobb¹, Marquan Martin¹, Jaala Brooks¹, Rickard Toomey² and Tom Byl^{1,3}

1. Civil & Environmental Engineering, Tennessee State University, Nashville, TN
2. U.S. Geological Survey, Nashville, TN

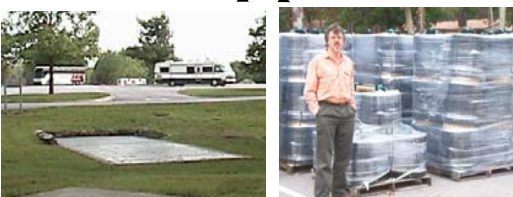
This field work was done prior to & after the filters had been refurbished. Filter system pictured above with parking lot up-gradient. Also shown, new leaf-packs to be placed in refurbished filters

Water samples were collected as the water flowed into the filters and out of the filters.

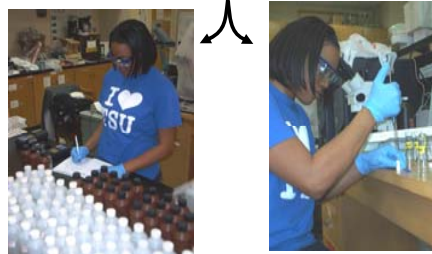
Water samples were brought back to the lab for chemical & biological analysis
